Evaluation Report

402

PRAIRIE AGRICULTURAL MACHINERY INSTITUTE

SPERRY NEW HOLLAND 1100 SELF-PROPELLED WINDROWER

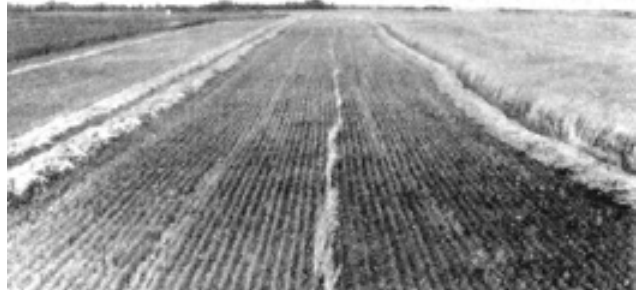
FIGURE 1. Crop Flattened by the Divider.

Dividers: Divider performance was fair. The wide divider flattened a strip of crop causing a slight crop loss (FIGURE 1). Cutting in the opposite direction on the next pass usually recovered most of the flattened crop. When double windrowing, this flattened crop could not be recovered because the windrower travelled in the direction of crop lean. The divider also flattened crop when making steering corrections or turning gradual corners. It is recommended that the manufacturer consider modifications to the dividers to reduce crop loss.

1. Modifications to the dividers to reduce crop loss.
2. Modifications to reduce knife drive vibrations.
3. Modifications to reduce draper plugging.
4. Increasing the power of the hydraulically driven drapers.

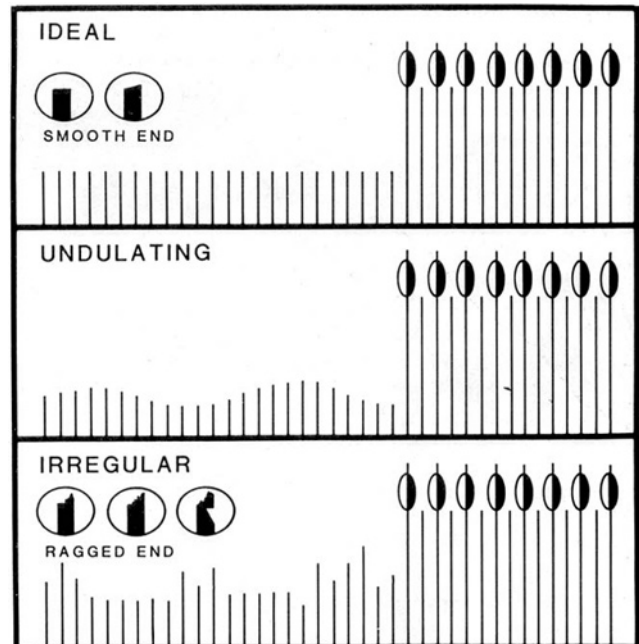
FIGURE 2. Types of Stubble.

Cutterbar: Cutting ability was very good in all crops provided the knife was maintained in good condition. Stubble was usually ideal (FIGURE 2). In rough fields undulating stubble resulted from excessive header bouncing. In tough green flax, material collected on dull sections and guards, plugging the knife.

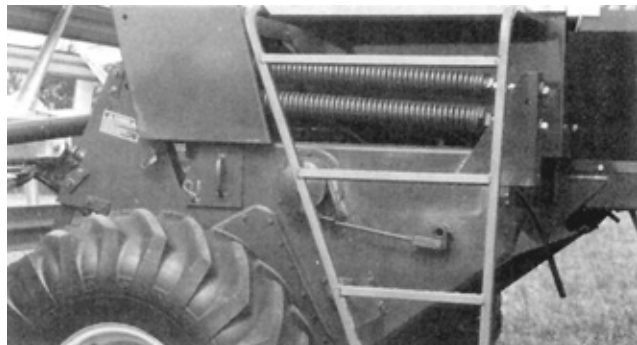
FIGURE 3. Header Flotation System.

Header Flotation: Header flotation was very good. Flotation was provided by four tension springs on the traction unit linkage (FIGURE 3). Good header flotation minimized cutterbar damage in stony fields and enabled the header to follow most ground contours. Undulating stubble occurred in rough fields.

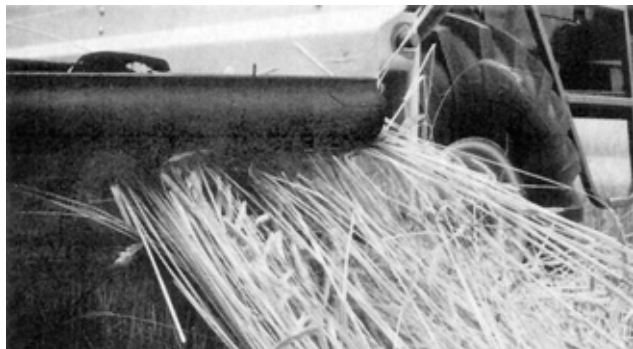
FIGURE 4. Plugged Draper in Fall Rye.

Drapers: Draper performance was fair. Draper speed could be varied from 0 to 500 fpm (0 to 2.5 m/s). In most crops, the drapers were run at full speed. Uniform windrows could usually be formed at this draper speed. However, in tall crops, such as fall rye and wheat and in heavy stands of bromegrass and barley, the drapers frequently plugged when material caught on the rear shields at the windrow opening. It was then pulled under the drapers where it caught on the cross braces, stopping the draper (FIGURE 4). Plugging occurred when centre and end delivering, but was most severe when end delivering because of the greater quantity of material on one side of the opening.

Factory representatives modified the draper cross braces and shields to reduce plugging. In the centre delivery opening, the draper motor shields and the rear draper guide were trimmed down. In the end delivery openings, the rear roller mounts were enclosed in shielding and the draper support straps were rounded and shortened. These modifications were not adequate as plugging still occurred in wheat and barley crops. It is recommended that the manufacturer consider further modifications to reduce draper plugging.

Windrow Uniformity: Windrow uniformity was good. Windrows were uniform in average and short crops at speeds up to 6 mph (10 km/h). In tall and heavy crops such as fall rye and wheat, bunchy windrows resulted when the drapers plugged, or when material caught on the rear draper shielding at the windrow opening. Modifications to reduce draper plugging have been recommended.

3. Modifications have been made to the header structural members to eliminate draper plugging. These changes will also be implemented on past production machines.

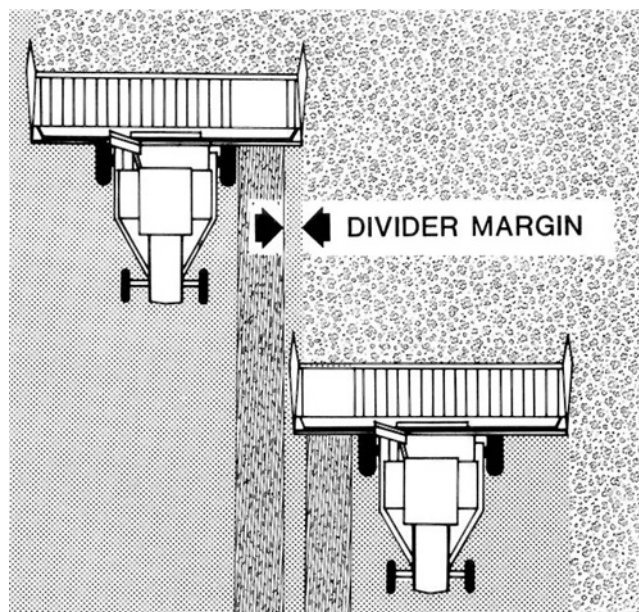
FIGURE 5. Double Windrowing.

When double windrowing, the right divider draper kept the first windrow about 12 to 18 in (305 to 457 mm) from the standing crop

edge (FIGURE 5). This kept the divider from snagging the windrow on the second pass.

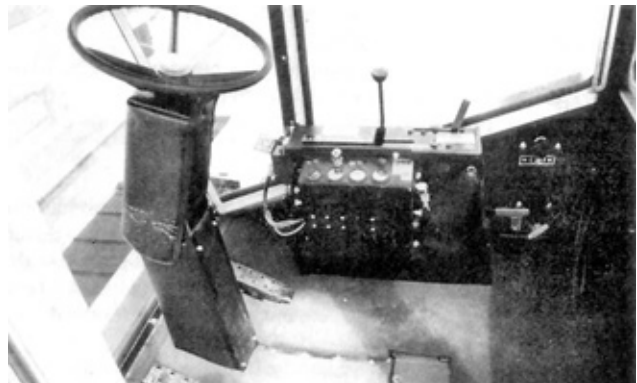
FIGURE 12. Operator Station Controls.

Controls: Ease of operating the controls was good. Most of the controls for the NH 1100 (FIGURE 12) were conveniently located and properly identified. The travel speed control lever and the range shifter were conveniently located and easy to engage.

permitted the cutting height to be varied across the width of the header. However, the two controls made it difficult to raise or lower the entire header uniformly. A pin supplied by the manufacturer to lock the pedals together was not useful because one end of the header dropped faster than the other. Also, the header dropped too fast. A restrictor was fabricated and installed by PAMI in the hydraulic line to slow down the lowering rate. It is recommended that the manufacturer consider modifications to the header lift system to make it more convenient to operate. The reel lift system was conveniently operated by one foot pedal on the right side of the steering column.

5. Modifications will be considered for future models.
6. A single header lift pedal, plus a "trim" pedal to allow header tilting from side to side will be retrofitted on past machines and included on future machines. The trim feature can be easily overridden or ignored if desired.

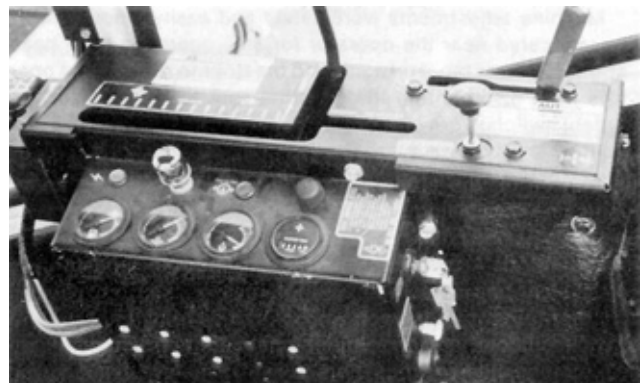
FIGURE 13. Instrument Panel.

Instruments: The instruments were very good as the console was conveniently located and easy to observe (FIGURE 13). It included gauges for fuel level, engine oil pressure, engine coolant temperature, and engine hours. Warning lights indicated alternator charge and hydrostatic oil pressure. An audible alarm signaled an unsafe operating condition. The instrument panel light shone in the operator's eyes which was annoying at night.
